R52WH74 Motherboard Component Replacement

This model is known to have issues with convergence. The screen will look distorted, almost 3D, and it will look bowed. Replacing the Fuse FL231 as well as the Diode DL231 and the capacitor CL230 should fix this.

Written By: oldturkey03

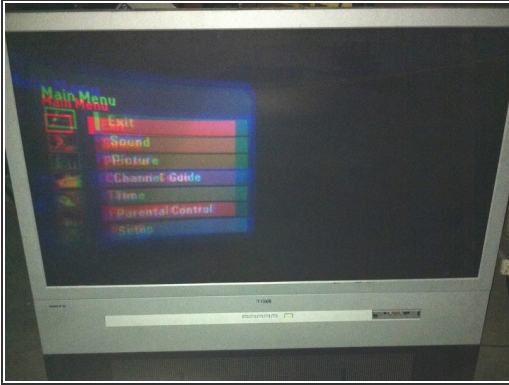
Step 1 — Convergence

- Here is what it looks like when the convergence is off.
- Remove the seven screws from the back.
- Remove the two screws from the left side.

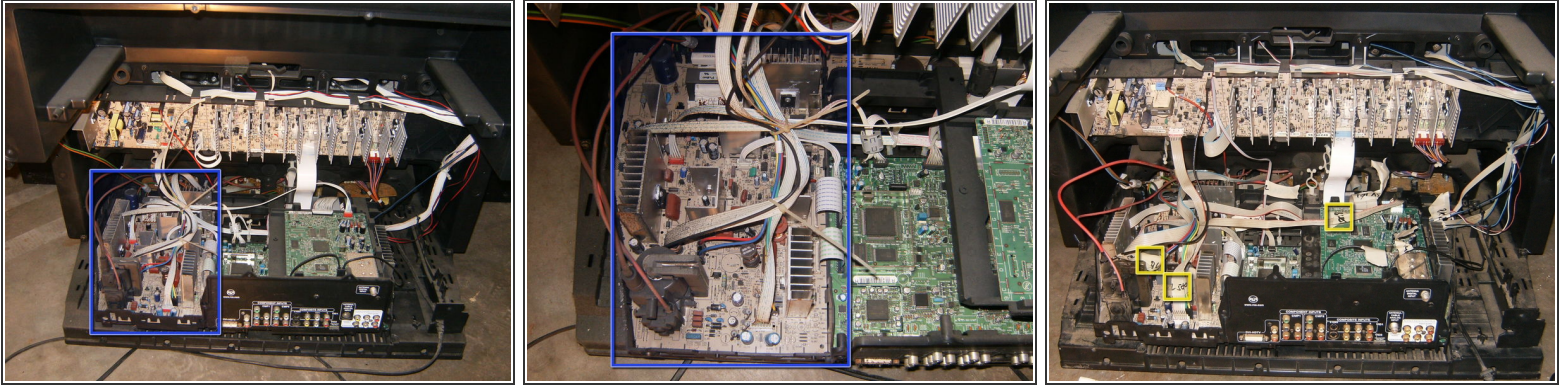
Step 3

- This is the deflection power board part number PSB-260
- Closer look on the the same boards reveals all the connectors (definitely not nice)
- Mark all the cables with a piece of masking tape and there relevant position on the board. This will make assembly easier.

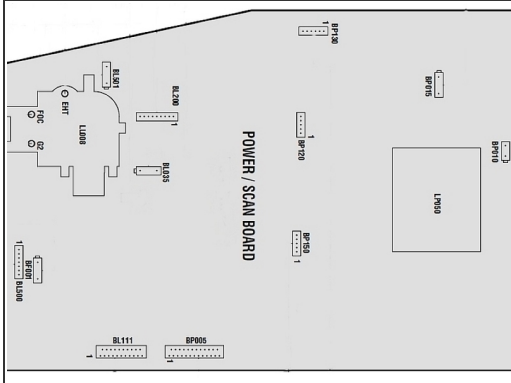
Step 4

- Drawing of the connectors on the Power Board
 - Remove all the cables from the power board. Each cable does have its own distinct connector and will not fit into another connector. This will make it easier to re-assemble the chassis.
- ⚠ DO NOT REMOVE THE RED WIRES FROM THE FLYBACK TRANSFORMER. Keep those attached.**
- To remove the flat ribbon cables from the BL111 and the BP005 connectors, just pull straight up on the cables. Hold the cable close to the connector end and pull straight up. They are compression connectors and have no clips.
 - The power board is held to the plastic chassis by 8 plastic tabs on the perimeter. Push those away from the board and toward the plastic side.

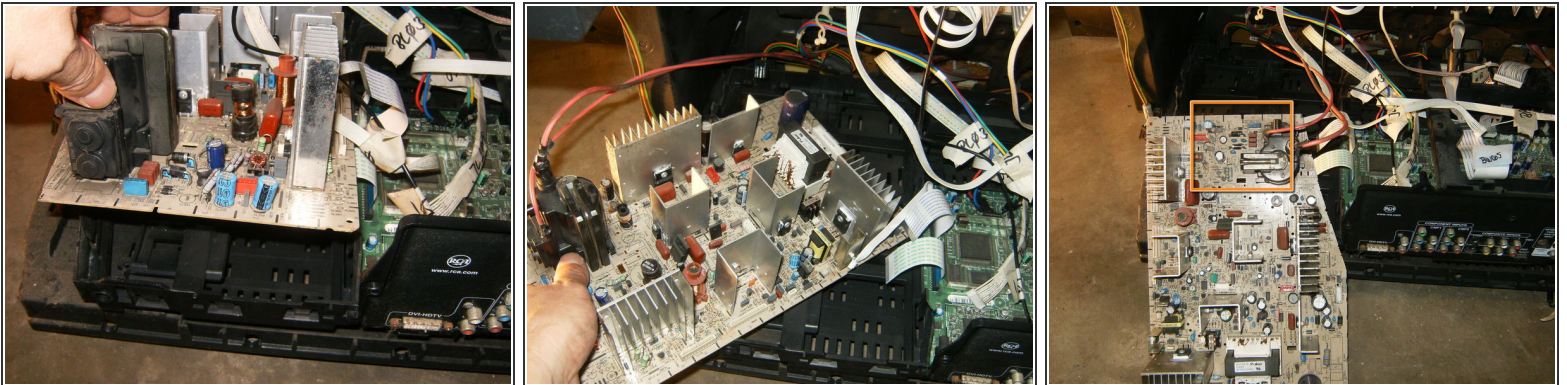
Step 6

- Continue to lift until the last of tabs has been cleared.
- With all the tabs cleared move the board out of the plastic chassis and slightly to the left. There should be enough room with the Fly Back Transformer cables still attached.
- With the board cleared of the chassis, this is the area that contains all the components that are to be replaced.

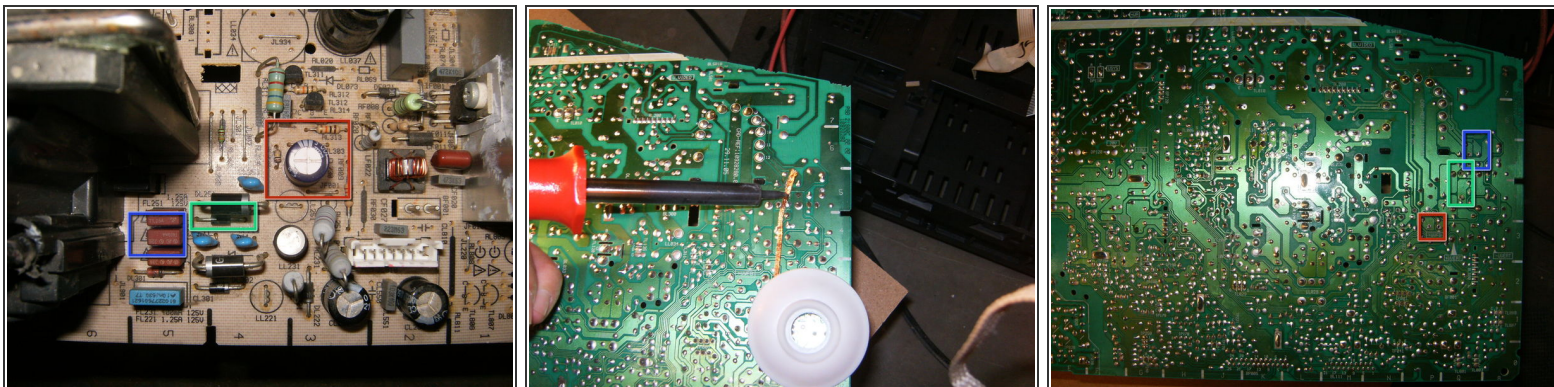
Step 7

- Here are the three components:
 - FL231 125V UL FA LL .400A TE5 fuse
 - DL231 Diode Rectifier 1A 600V
 - CL230 Capacitor 100uF 100V
- Unsolder all three components. Use solder wick and some flux, or a solder sucker.
- View of the solder side with components removed.

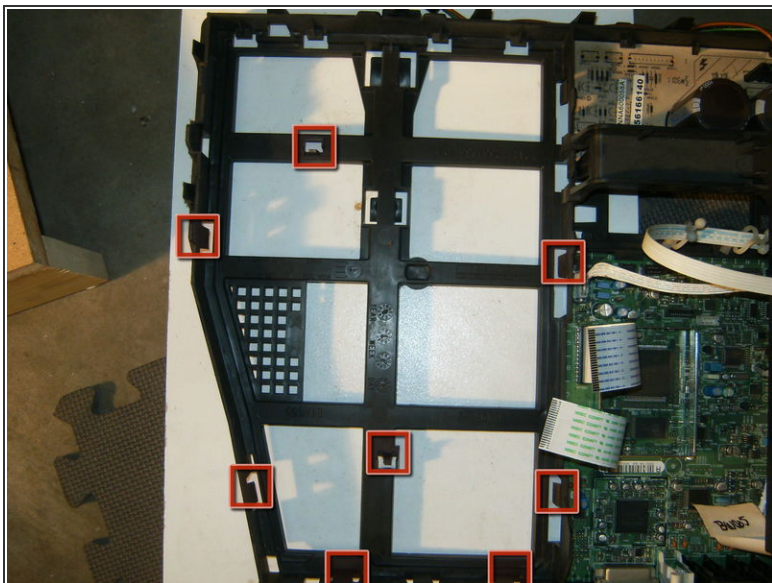
Step 9

- With the components replaced it is time to reassemble the TV. Here is another look at the plastic chassis with all the clips.
- Hopefully your results will be like mine. Perfect convergence. Totals cost for the repair \$1 for parts and \$5 for shipping. Total time about 2 hours.
